Manhole Inspection Summary

Manhole # S07WW_008MH

Insp Date: **7/21/08 9:33 AM**

Location Address: **3700 LIBERTY HEIGHTS AVE**

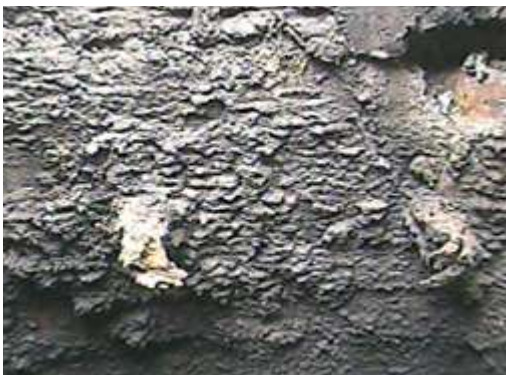
Defect 1

Count: **6** Missing: **1** ☒ **Corroded**

CORRODED/MISSING RUNG

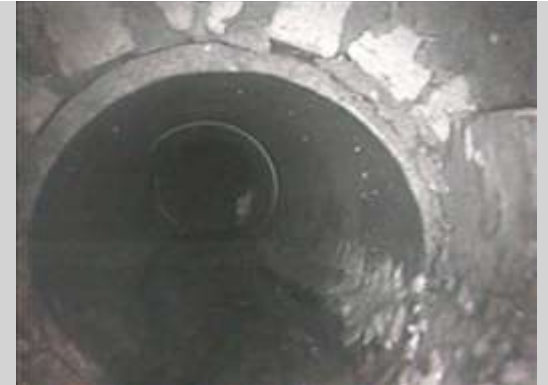
12 O'Clock Outflow

10 in. Circular Gravity Sewer
Pipe Out @ 12 O'Clock

Pipe Height: (in.) Direct
Pipe Material: **Clay** ☐ Pipe Lined
Invert Depth: **11.36** (ft.) Flow Characteristics: **Fast**
Deposits: ☒ None ☐ Mud ☐ Sludge ☐ Debris ☐ Grease
Silt Depth: (in.) Deposits Extent:
Infiltration: **None** Pipe Seal Cond: **Sound**

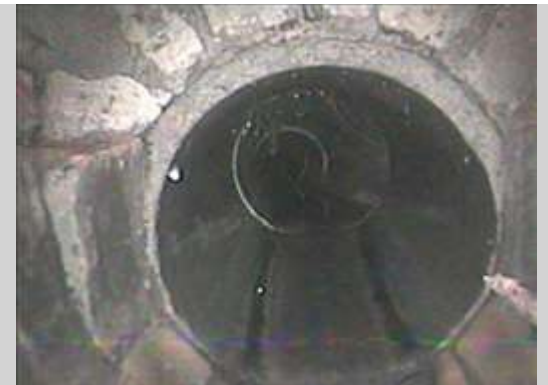
3 O'Clock Inflow

8 in. Circular Gravity Sewer
Pipe In @ 3 O'Clock

Pipe Height: (in.) Direct
Pipe Material: **Clay** ☐ Pipe Lined
Invert Depth: **11.12** (ft.) Flow Characteristics: **Fast**
Deposits: ☒ None ☐ Mud ☐ Sludge ☐ Debris ☐ Grease
Silt Depth: (in.) Deposits Extent:
Infiltration: **None** Pipe Seal Cond: **Sound**
